# Utilization of treated tannery effluent for afforestation

## A case study: Sipcot, Ranipet, India

P.R. Kavitha and G.P.Ganapathy

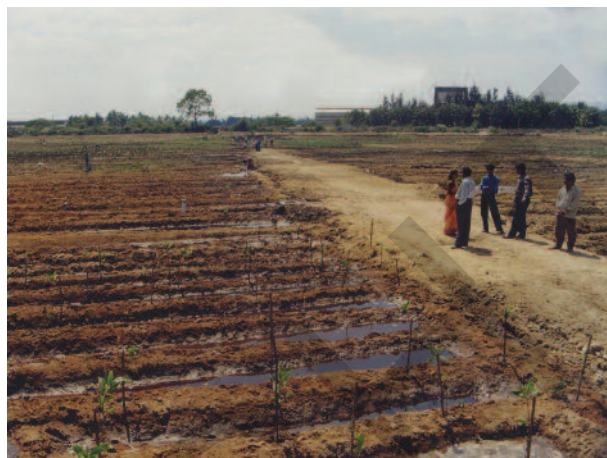
This shows the 10 acre area that was previously barren immediately after planting with various tree species in 1999, and the method of irrigation that was used.

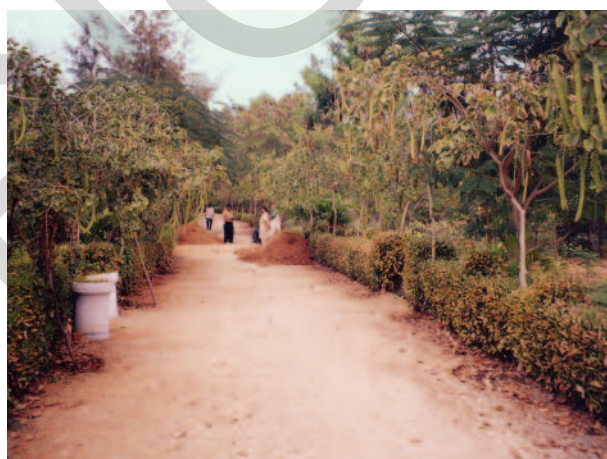
This image shows the same area four years later. The growth rate of the trees has been impressive, and hedges have also been established.

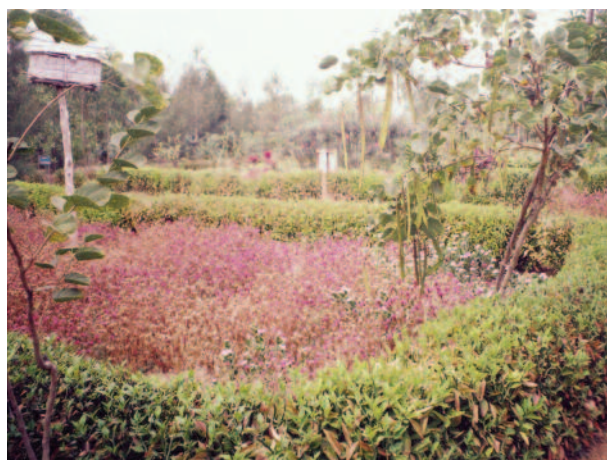
In addition to the original trees and hedges flower gardens were established with a wide variety of plants. An area was also set on one side for a summer house in the centre of the area.
