## Some barn, some leather

To Roy Thomson, the head of the UK's Leather Conservation Centre in Northampton, the call from the curator of one of South Africa's most prestigious buildings was the perfect antidote to a grey winter's day in February this year. In quick time he and two colleagues found themselves flying down to Cape Town to advise on the leathers used in Groote Schuur—the big barn, in Dutch—and to rehang leather panels in the magnificent rooms of the official residence of the president of South Africa.

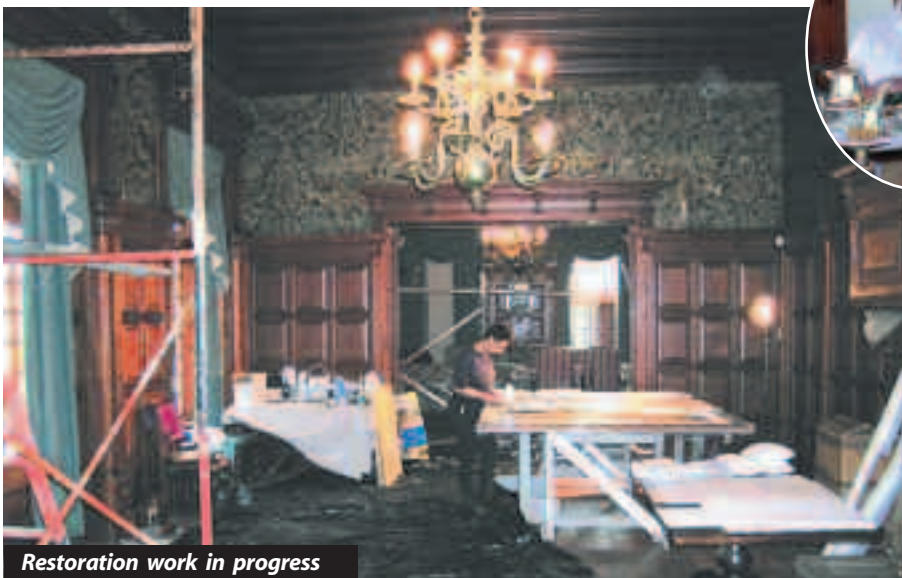
Restoration work in progress

The 17th century panels had the plaster and paint mechanically scraped away from the backs and the original adhesive was carefully treated with solvent and rubbed away.

The cleaned panels were then humidified using semi permeable membranes, allowing water vapour to transfer into the fibre structure of the leather, softening it without permitting potentially damaging water to come in contact with the leather. Archival grade leather was again used to repair any holes, splits or damaged edges. The repaired areas were then infilled using a pigmented BEVA thermoplastic wax/resin melted into place.
